I truly fell in love with my L-36 *Eagle Borne*. As a tinkerer and DIYer I found (or made up?) more new and exciting projects than a mad scientist in a chemistry store. In an effort to make her more seaworthy, safe, comfortable, and beautiful, I worked on her continuously. Projects sometimes overtook my coveted sailing time, as in the case of the engine failures and the hole in her bottom. Everything took twice as long as I initially figured, and many of the projects were twice as expensive. Nevertheless, I doggedly continued until I conquered them all. There are still some projects that I once had intended to do first that never were done at all. Priorities change. Still, I think she's undergone enough of an overhaul that the burden of continued maintenance will subside to an easier pace.

Here is a list of the upgrades and repairs I made on Eagle Borne since buying her in 2004. Not everything was done to master shipwright standards, but everything was done – and done with my own two hands. There are many smaller repairs and upgrades, like caulk and some minor rewiring, that did not make this list.

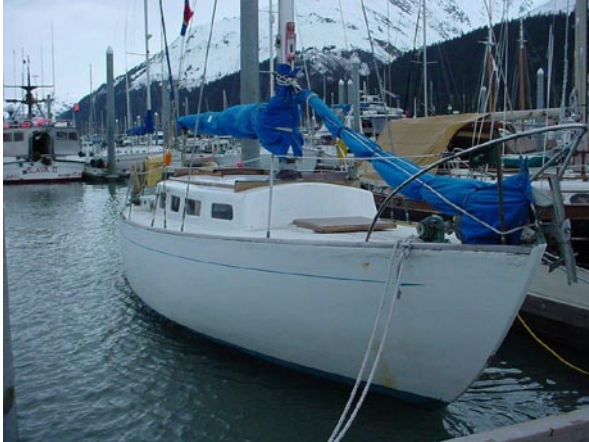
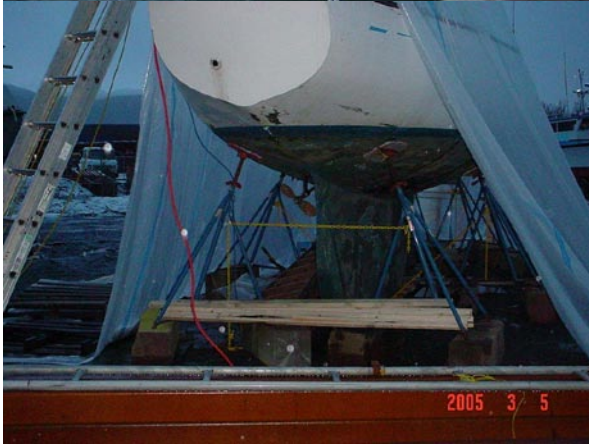
*Hull condition in April, 2004.  
Getting started, February 2005*

**Hull refinishing.** I scraped and sanded from the toe rails down to the keel foot and refinished her bottom and topsides. This has been written about in my earlier posting, but summarily I prepped and faired with West System epoxy, gave her bottom two coats of Kirby red lead and three coats of West Marine Bottom Kote Gold, and I gave her topsides with three coats of Interlux Toplac. I was very proud of the transformation. She's a beautiful Largo Blue with white accent stripes and a red boot stripe. I also made a laminated wood-grain name-board for the transom.

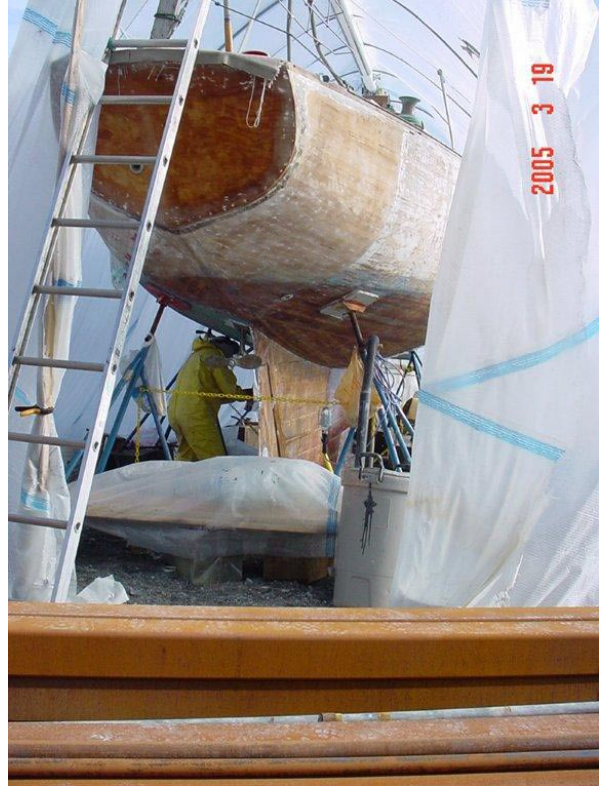
*The hull refinishing project -  
stripped bare*

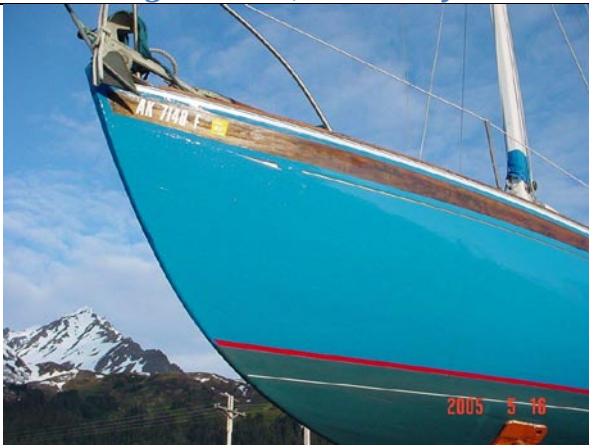
*Hull condition in May, 2005*

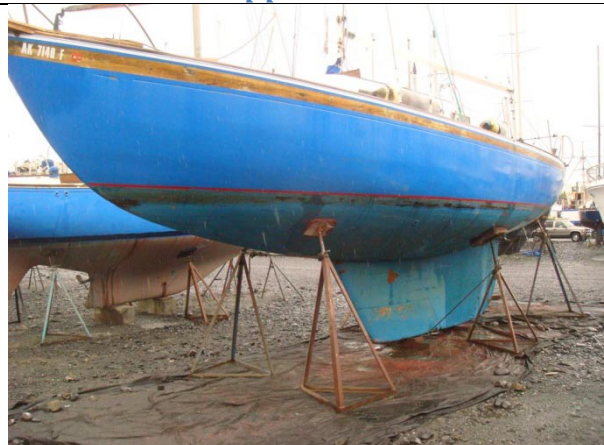
*Hull revisited, June, 2010.*

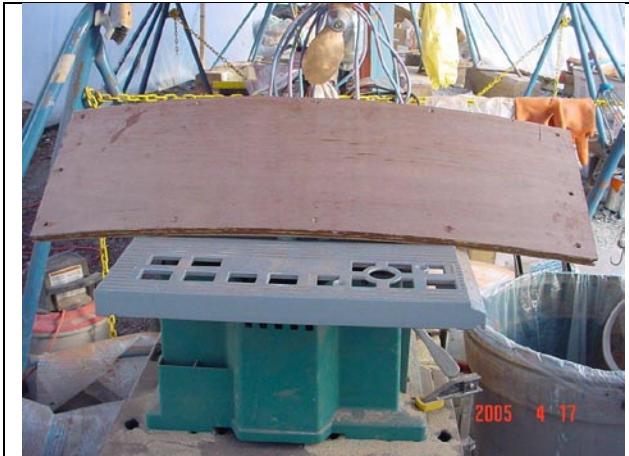
*Laminated name board, pre-curved to fit transom.*

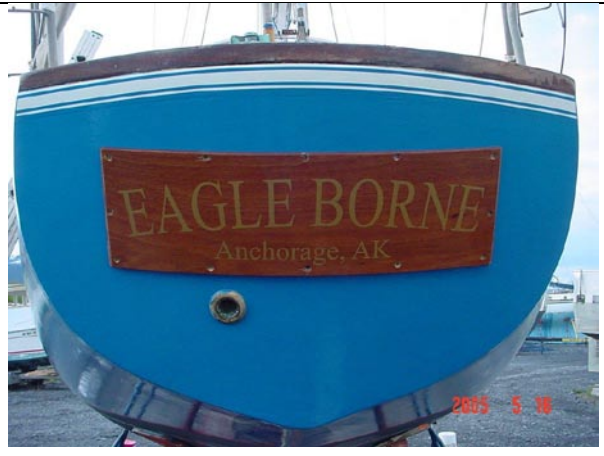
*Finished name board.*

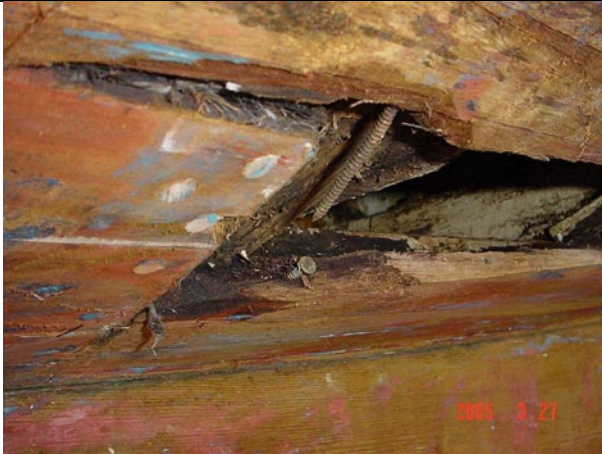
**Hull Repair.** During the refinishing I discovered a soft rotten spot on the port side, below the engine, near the garboard. The initial soft spot felt about football sized and shaped. I hacked and dug out all soft wood, and then cut a scarf joint with my worm-drive skill saw. The new hole was about 1'x4'. Using 1"x1-1/4" mahogany strips I laminated a dutchman with thickened West System epoxy. It looked like a laminated butcher board. The edges were hand-formed to mate with the scarf joint and sprung into place. The dutchman was proud by about 1/8" which allowed me to belt sand her fair. I laid white oak backer boards cross-grain under the engine to reinforce the attachment points. It all was screwed with silicon-bronze screws and glued with West System epoxy, then faired, sealed, and painted. I'll bet you can't see the repair from the outside.

The rot occurred under a little puddle of rainwater that developed where a limber hole had gotten plugged. Plugged limber holes have been a consistent challenge. Somewhere in Eagle Borne's history her bilge was painted white. Now these paint flakes form little dams over the limber holes. Rainwater is especially harmful in a wooden bilge due to bacterial growth and rot. See the sections on *New Dodger* and *New Winter Cover* for a brief description on keeping rainwater out.

*The original hole hacked away with a claw hammer*

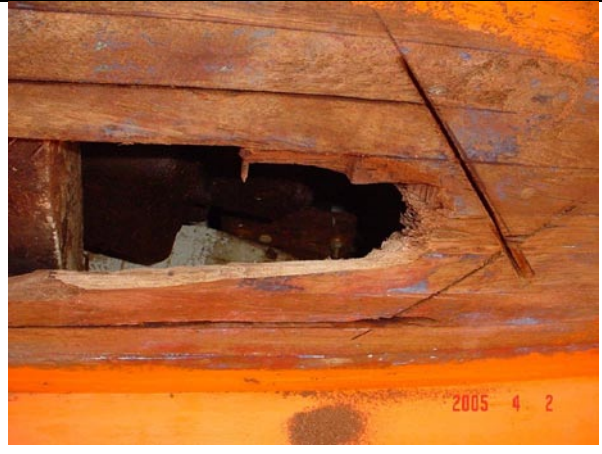
*As the rot was removed the hole got bigger. Saw lines in solid wood are visible around the hole.*

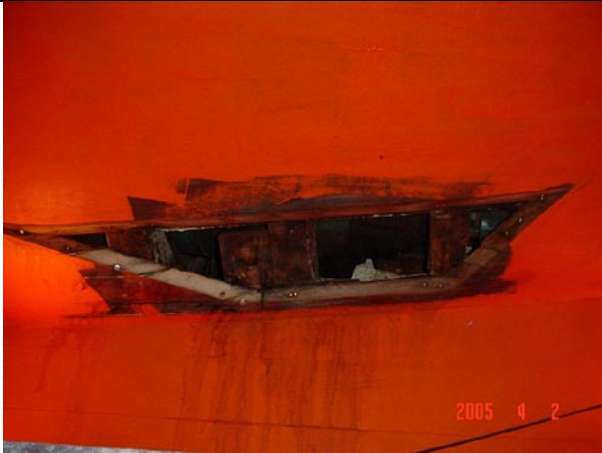
*The finished hole with scarf joint all around*

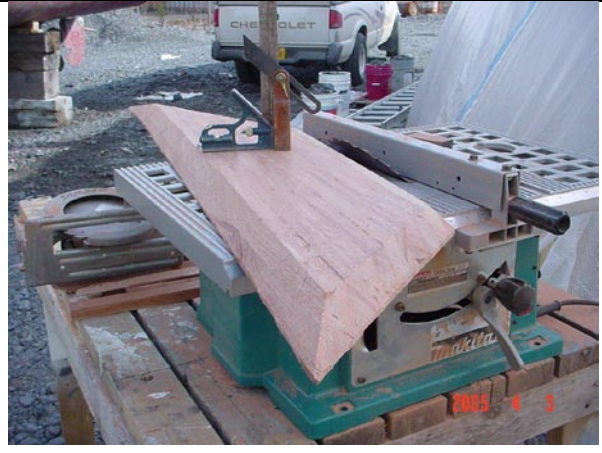
*Mating dutchman with scarf joint all around*

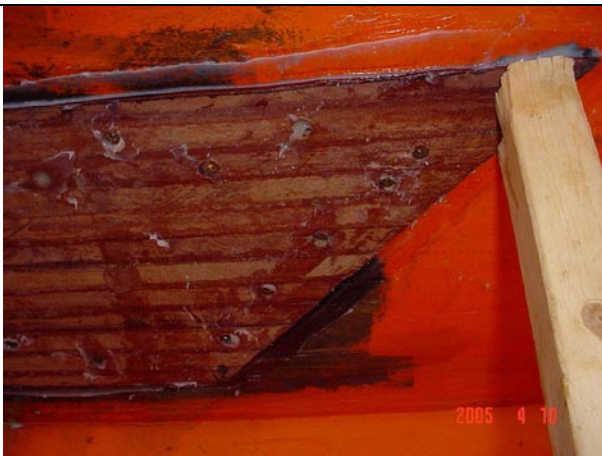
*Dutchman sprung into place, screwed and glued.*

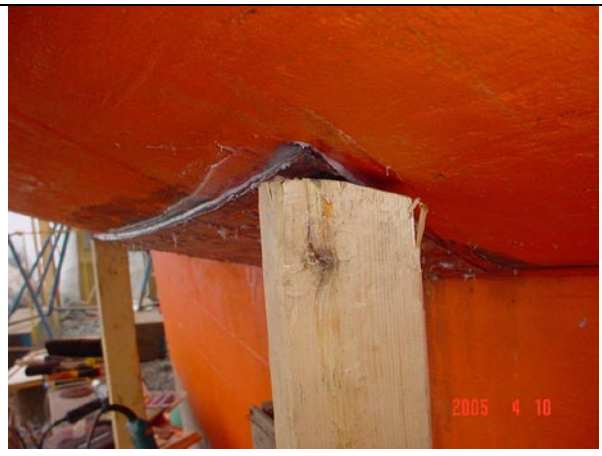
*Curvature of the dutchman when sprung.*

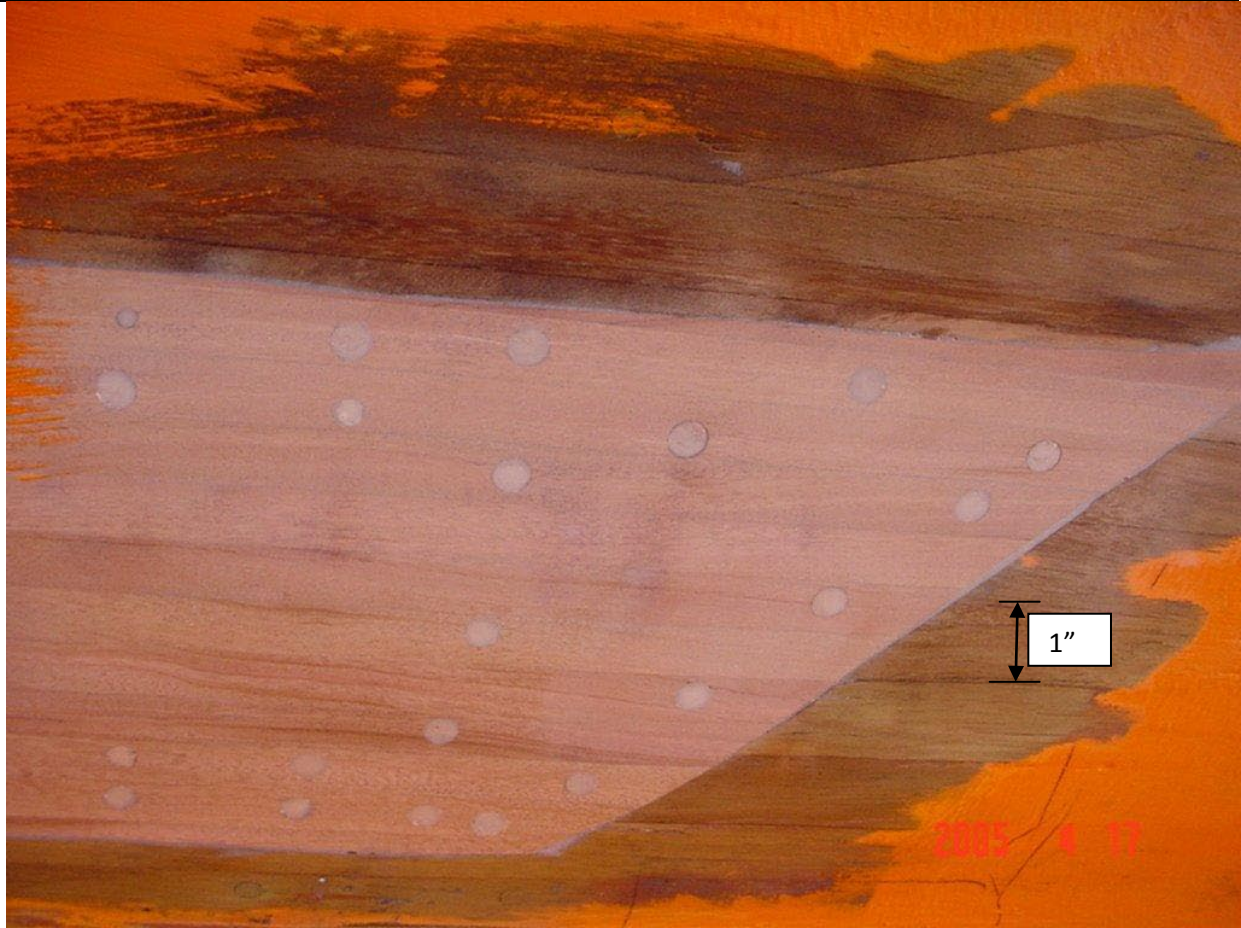
*The dutchman after fairing to match surroundings. These joints are nearly imperceptible under the paint. Inspection in 2010 showed no loss of integrity.*

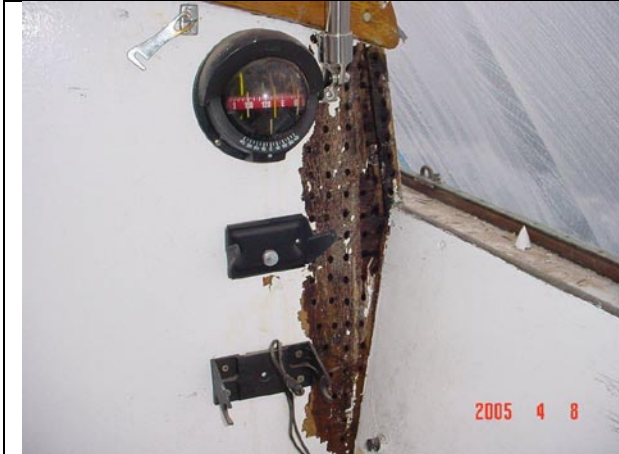
Some rot was discovered on the starboard bulkhead between cockpit and cabin. This was from water working under the paint, finding a coachroof joint, and running down the joint to the bulkhead. This is rainwater – again. I perforated the bulkhead with a ¼” drill and soaked it full of Git Rot™. Then I refilled the perforations with thickened epoxy.

*Perforations for Git Rot infusion.*

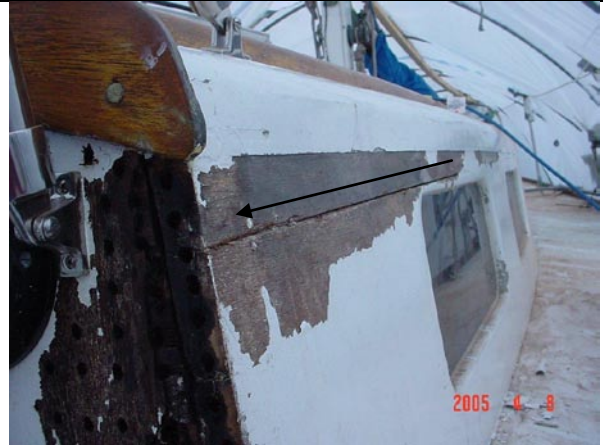
*Coachroof joint that the water ran along to soak the bulkhead.*

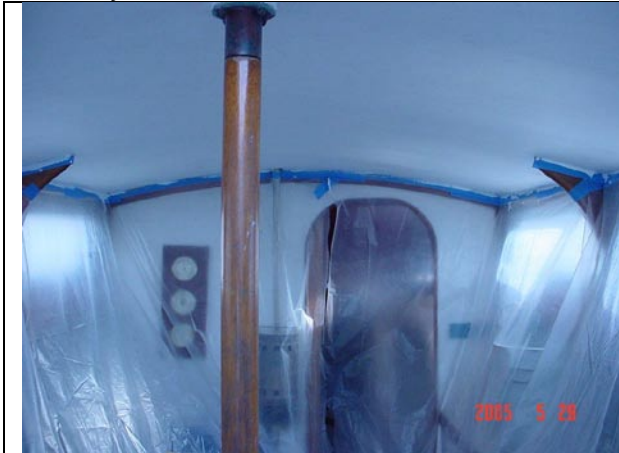
*If you mask the edges, you can spray several coats. For cleanup, just rip down the plastic wrap.*

**Cabin refinishing.** A coat of glossy white Briteside on the headliner and bulkheads made a great difference. Add to that some bright work, and she now has a nice, cared-for, salty look.

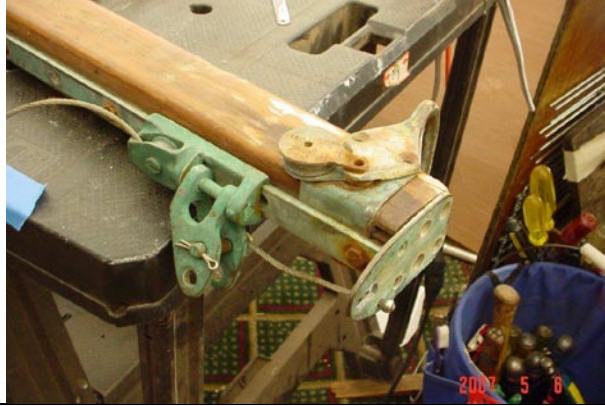
*Clubfoot hardware just prior to disassembly.*

*Iron bolts had corroded and stained the bronze fittings.*

**Clubfoot refinishing.** The clubfoot jib is delightfully self-tending but the original mahogany clubfoot was in disrepair. I disassembled all of the hardware at both ends, finding considerable corrosion on the through-bolts. I fashioned a few reinforcements, reassembled all components, and re-bolted it all. Then I sanded and varnished the pole, and filled some cracks and checks with thickened epoxy. She's a beauty now, with most of the original hardware, and she works like a charm.

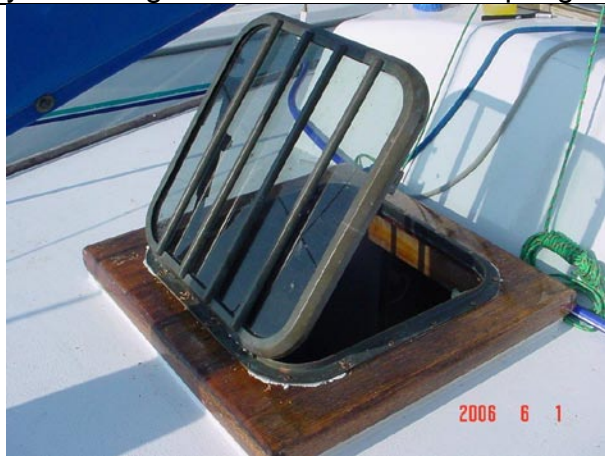
*Hinge forward bronze-framed light installed in foredeck hatch.*

**Foredeck Hatch upgrade.** The foredeck hatch had a laminated mahogany, lift-off cover, about two foot square. Underneath, the V-berth was dark. I cut an 18"x18" hole in the cover and fitted a classic, bronze-framed, hinged, glass deck hatch. I then hinged the original cover. The glass hatch is mounted with the hinge forward, so she can take a little spray when open. We find that in a headwind, this arrangement draws air in the companionway and exhausts it out the hatch. The wooden frame is mounted with the hinge abaft, so it scoops air.

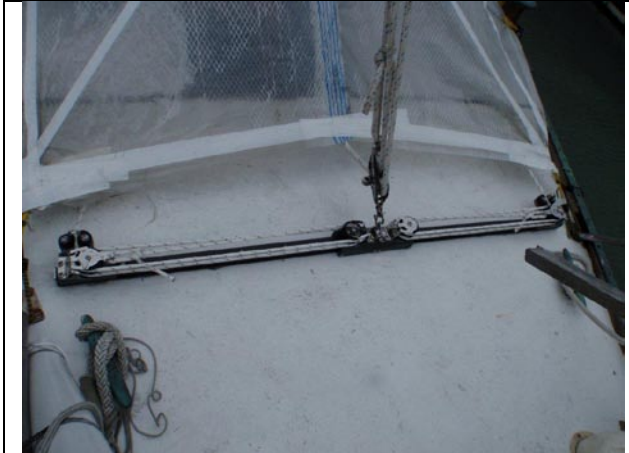
*New Garhauer mainsheet traveler. You can also see the edge of the prototype cockpit cover.*

**New Mainsheet Traveler.** I replaced the original mainsheet traveler with a new SS model by Garhauer. The new traveler has 4:1 ball-bearing blocks with lines for positioning the ball-bearing-wheeled car (port – starboard) with a separate main sheet for hauling in – or out the mainsail. The old traveler had a simple bronze car on a mating slide. Friction prevented repositioning under load. The new traveler can be repositioned under load, and its travel is about 50% more than before.

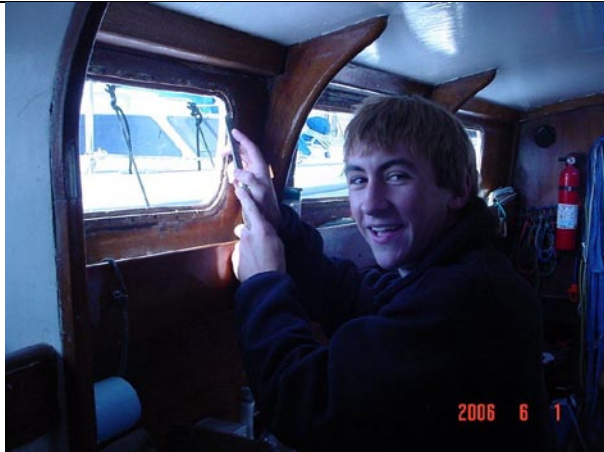
*Spencer’s friend cleaning the portlight frame with a chisel.*

**Port Light rebedding.** All of the port lights were leaking. We removed each one, cleaned the mating surfaces, formed a gasket of 1/8” resilient foam weather-stripping on the cabin side, ran a bead of caulk on the weather side of the glass, and reassembled them using square drive, silicon bronze screws. Each port light has about 25 screws, and there are eight lights. (Eagle Borne doesn’t have the two forward-facing “eyeballs” on the coachroof). In order to get good purchase with new screws in old holes, we stuffed each hole with toothpicks and then injected a bit of Gorilla Glue. We left the screws lightly snug until the caulk had cured, and then drove them home about one more full turn. Not one has leaked since.

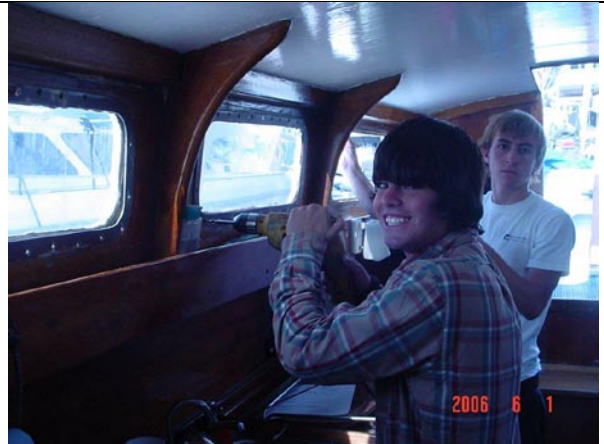
*Spencer’s friend installing cleaned and prepped portlight*

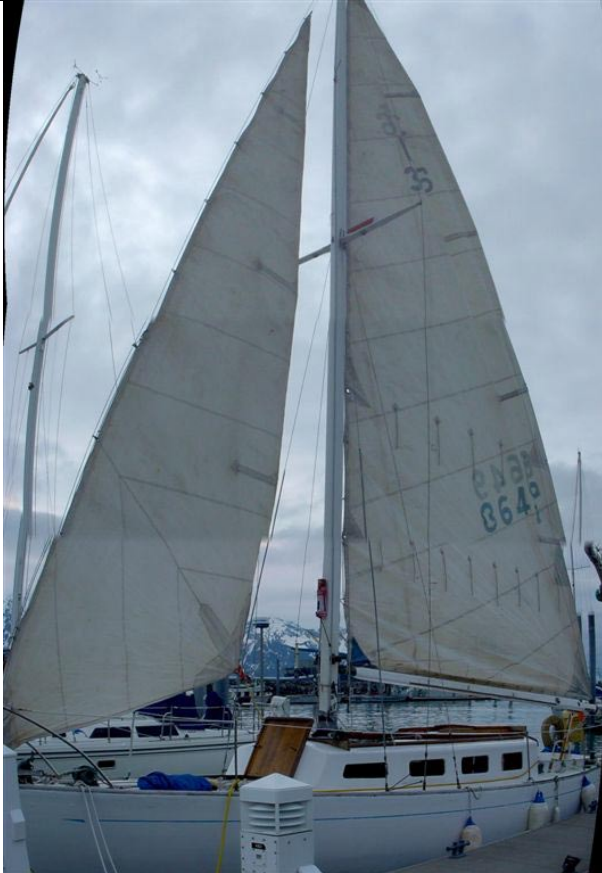
*Old mainsail before Spencer and I drove her too hard.*

**New Canvas.** Spencer and I ripped her mainsail on the last day of the first season. Since all of the sails onboard appeared to be the same vintage (1968) from Sausalito, I

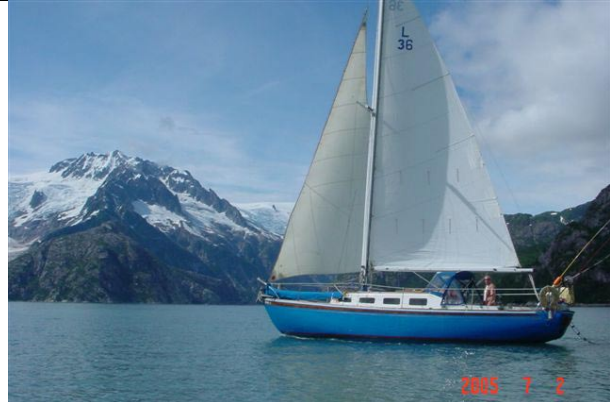
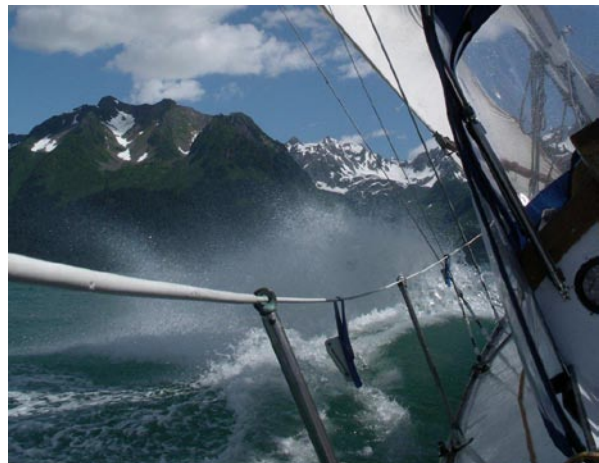
*New mainsail with L 36 insignia. New main sail can drive Eagle Borne hard upwind.*

guess it was inevitable. I had our local sailmaker, Mike Leech at Marine Fabric Crafters build a new main with two reefs out of 8oz Dacron. Her foot came up a couple inches short (who did the measuring?!?!?) so I spent quite a while finding a long shackle to fit the gooseneck and a comparable arrangement where the outhaul attaches to the clew. Thanks to a second-hand shop in Port Townsend all is fine. We have 5 headsails, four of which hank on to the forestay. The fifth is an inner staysail which has its own padeye and 3/4-rigged halyard.

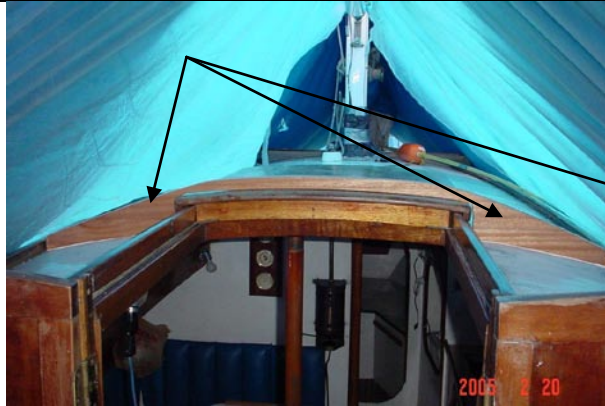
*A custom yoke formed a bridge over the hatch for dodger mounting.*

**New Dodger.** In Alaska I can't imagine sailing without some protection from the weather. I had Marine Fabric Crafters design and build a dodger which we love. I added a yoke to bridge over the companionway hatch track to which the dodger attaches. The trailing edge of the dodger is also the attachment point for a reinforced visqueen cockpit cover. This provides a "greenhouse" in which to enjoy morning coffee, a rain cover for the helm when motoring, and protection from wet and rot in the cockpit. It rolls up in a minute on nice days and stows easily in a small package when sailing. I was planning to have a proper one made of more durable materials, but I guess that can be Grady's and Spencer's project someday.

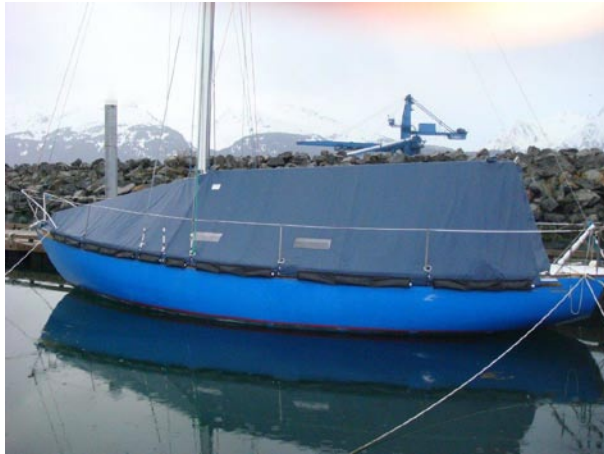
*Winter cover made to protect through an Alaskan winter.*

**New Winter cover.** In Seward, Alaska, the winter can bring heavy snows, hard rains, deep freezes, and hurricane winds. I again enlisted Marine Fabric Crafters to make a full-length cover. It uses the boom and clubfoot as ridgepoles and hangs over the toe rails with zip-off sandbags and nylon tie-downs. It has a zipper door abaft the cockpit. The winter cover protects the entire vessel from wet and rot.

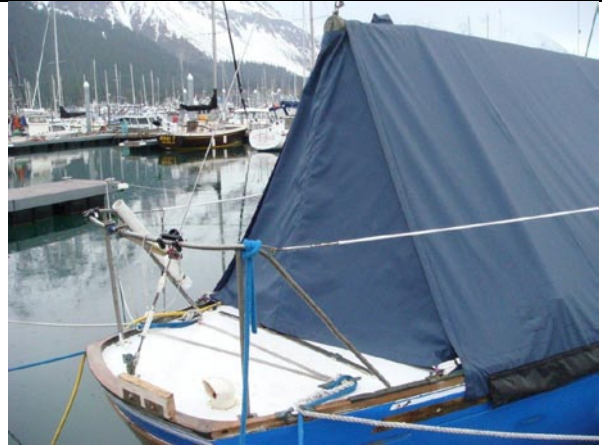
*Rear zipper entry.*

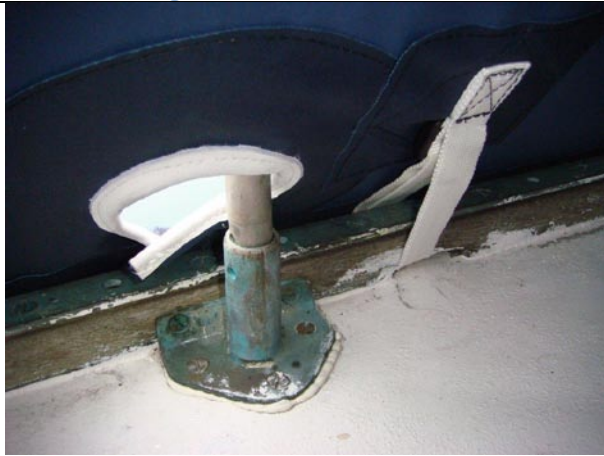
*Typical tie-down and reinforced hole for stanchion.*

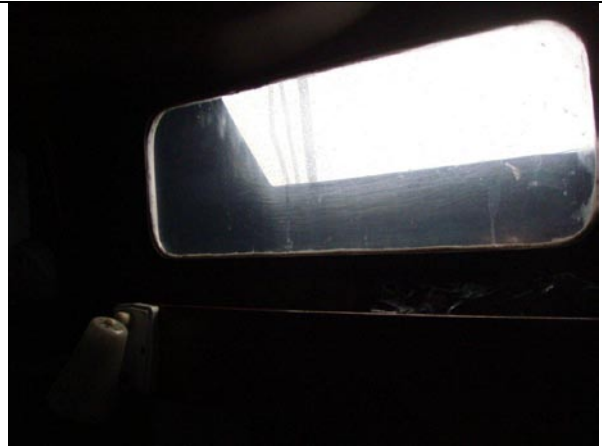
*Cover had windows aligned with port lights so the cabin wouldn't seem like a cave.*

Since previous tarps that I had used gave the cabin a cave-like feel in winter, I asked Mike to sew in a couple windows. I often stay overnight when I go to Seward to check on Eagle Borne, and at least with the windows I can tell if it is day or night.

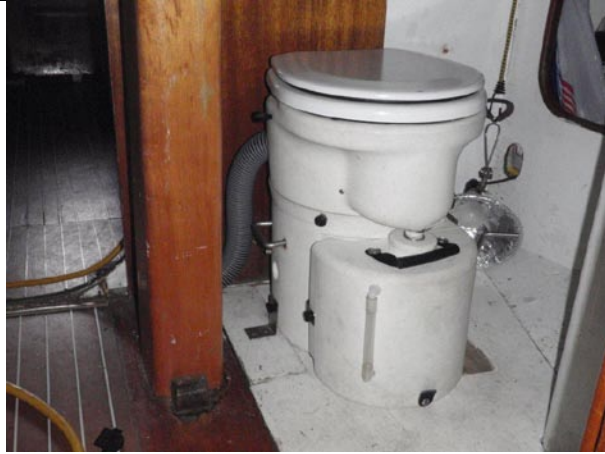
*Composting AirHead.  
In Alaska's cool weather I  
sometimes leave a 40 watt light on  
the bin to accelerate the compost  
action.*

**New Composting Head.** I replaced the marine head with an AirHead™ in about 2006. The old head did not have a holding tank and the necessary carpentry and plumbing to install one seemed an overly large and complex project. The Airhead has no water or discharge connections, so I was able to permanently close two thru-hulls below the water line. It's a wonderful addition, which works year round and requires no winterizing. It has a small 12 volt ventilating fan (about the size of the cooling fan on a PC computer) that draws a fraction of an amp. It sucks air from the bilge, through the composting bin, and blows it out a deck fitting. I let it run 24/7/365. The battery bank is virtually unaffected by this tiny load.

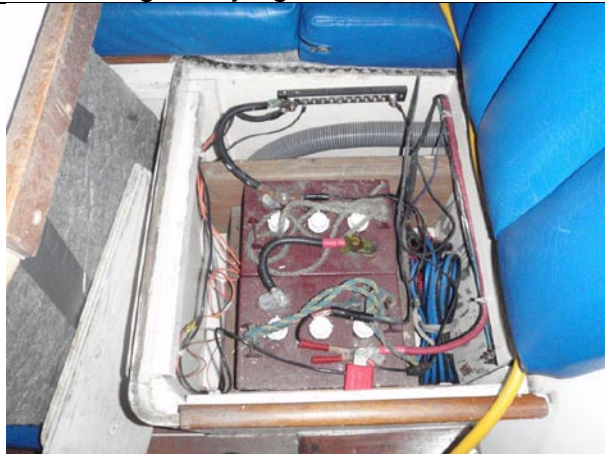
*Dual 6 volt batteries in series.*

**New Battery Bank.** Beneath the forward saloon seat, I added two, six-volt golf-cart batteries in series for the house bank giving us 200 amp-hours. I also carry a 12 volt starting battery and one spare 12 volt battery. I added a master selector switch which allows either bank or both banks to discharge or charge. I also added a Deltran™ smart trickle charger for each bank. These 2 amp chargers (about the size of a deck of cards) are potted (waterproof), solid-state devices safe for the marine environment and automatically switch between three charging stages: constant voltage (14.2v), constant amperage, and intermittent maintenance. I can keep them plugged in all winter without overheating or drying the batteries out.

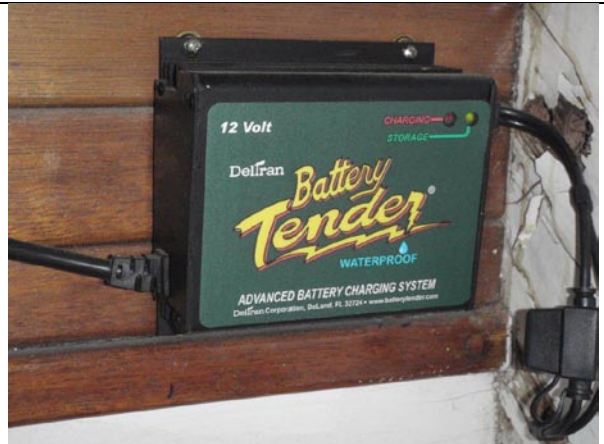
*Smart Battery Charger.*

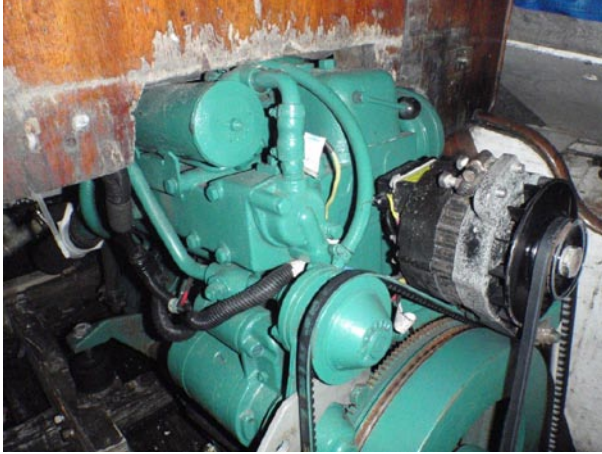
*High output alternator on the new engine. The alternator just barely fit over the fresh water pump belt and required a custom belt tensioner.*

**New High Output Alternator.** When the original alternator failed, I replaced it with a 135 amp Balmar model. Although it was slightly larger diameter than the OEM alternator, it fit on the OEM brackets. Additional modifications were needed once we added the fresh water cooling kit

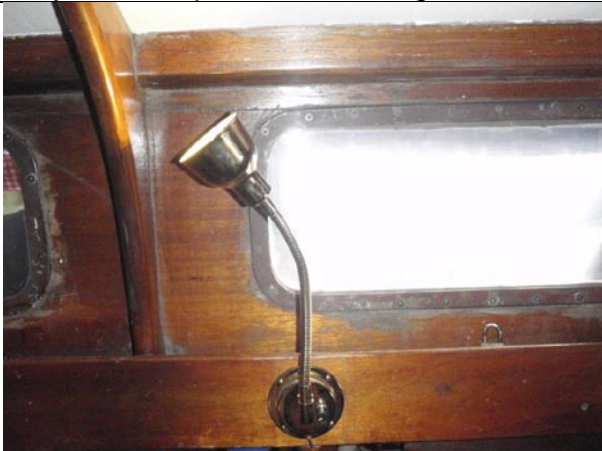
*LED light can be aimed and is dimmable.*

**New Saloon Lighting.** I added three Sailor Solutions reading lamps with their dimmable LED Sensibulb™ in the saloon and one four-foot LED bar light over the galley. These provide better light than before and hardly draw down the batteries at all.

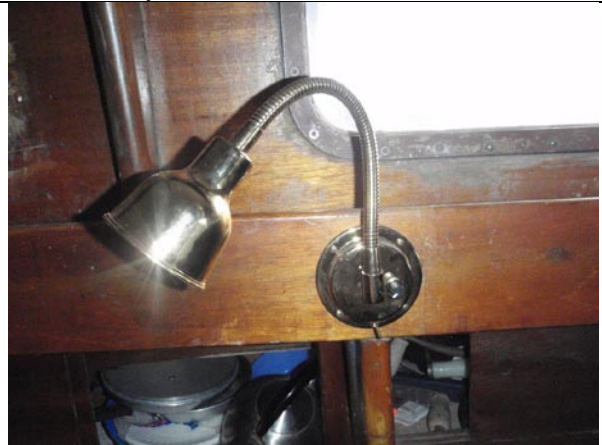
*One of three LED saloon lights*

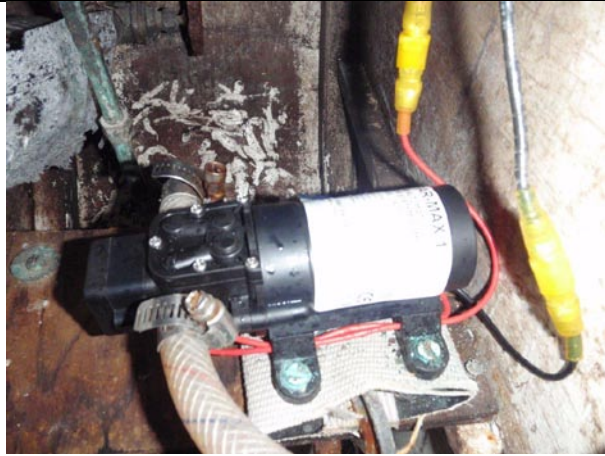
*Galley water pump on flexible mounts*

**New Galley Pump and Sea Water Bypass Valves.** I replaced the old 12 volt galley water pump with a new Jabsco pressure activated galley pump and rewired its main power switch. It is quieter and more reliable. By adding a few valves and a bypass between the seawater intake and the freshwater tank I can select whether I want the pump to pump sea or fresh water. This is useful while cruising to conserve water. The hand pump over the galley requires “work”, so we connect it to the precious fresh water. The electric pump is “easy” so we connect it to the free seawater. In the harbor, where we have unlimited supply of fresh water, we switch the electric pump to the fresh for ease and convenience.

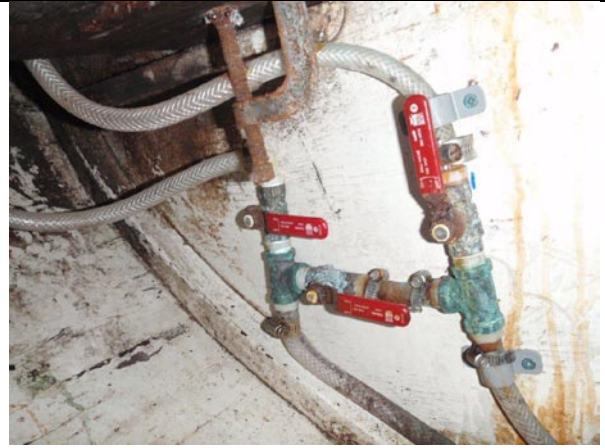
*Fresh / Salt water bypass valves.*

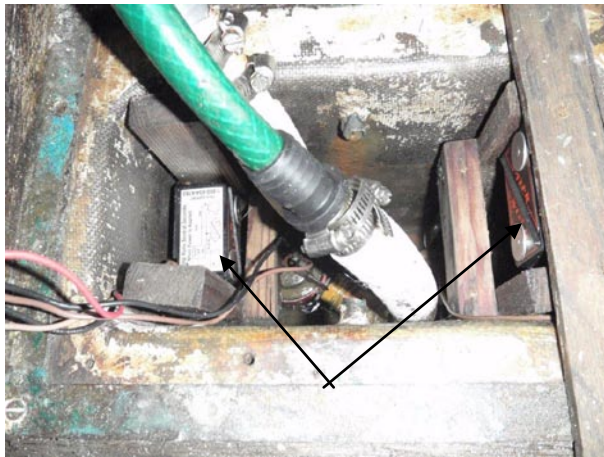
*Dual bilge pumps in the keel well with dual Water Witch switches mounted about 4" apart vertically to give primary/backup operation.*

**New Bilge Pumps.** I built a frame to mount two, 2000 GPH Johnson bilge pumps in the bottom of the keel well. At the top of the frame, I installed two Water Witch™ electronic switches about 4 inches apart in elevation. These switches have an off-delay that allows the pump to run until the keel well is pumped down to the bottom. This means that water never rises above the keel well. When the pump does run, water drops about 12 inches. The pump is sucking air on the bottom of the well before it shuts off.

The frame is held down in the well with a retainer, but can be lifted out in one piece for inspection and service. The duplex arrangement allows one pump to serve as back-up in case of failure of the primary, or in case of overload of the primary. The two outlet hoses wye together with a vacuum breaker and discharge overboard.

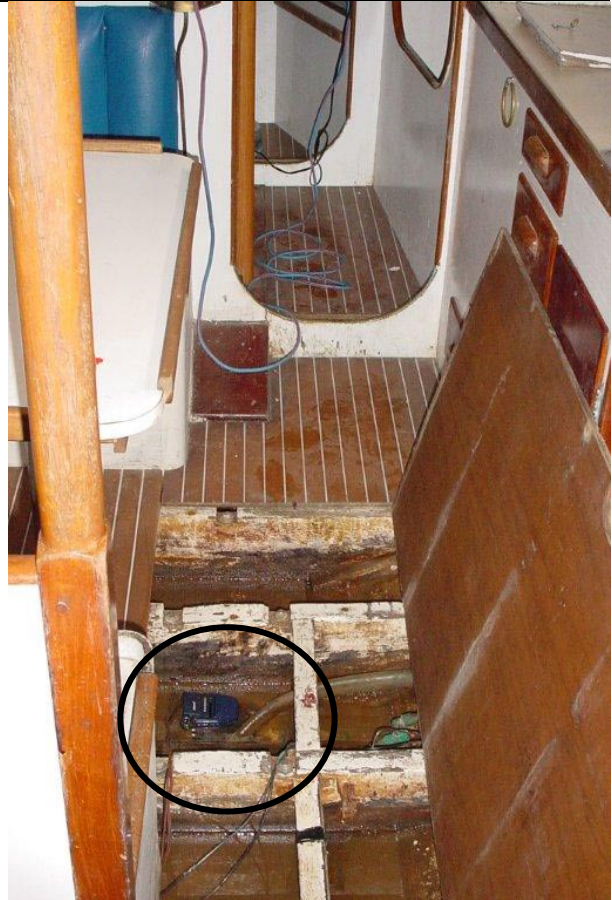
*The old float switch allowed about an inch of water to stay in the bilge. It would switch off after water receded about ½ inch.*

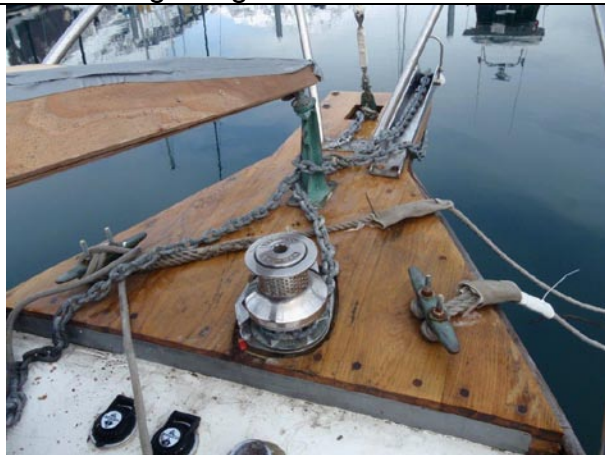
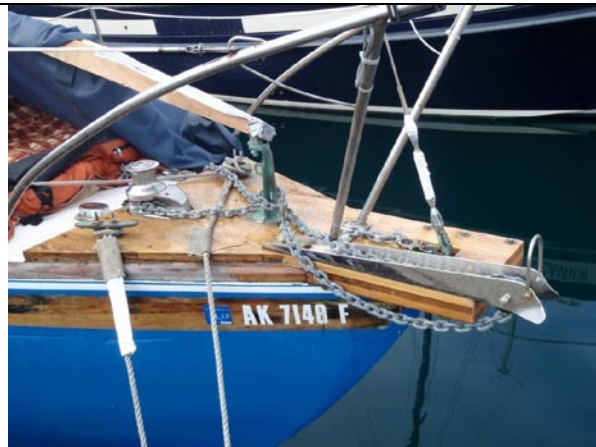
*White oak apron with windlass hardware. In these photos, the anchor has been led back to the foredeck for the winter and multiple winter dock lines criss-cross the apron. In the sailing season the 35# Delta anchor rests in the Garhauer bow roller.*

**New Ground Tackle and Electric Windlass.** After losing my anchor to Neptune, I decided to upgrade my whole ground tackle system. In our deep south central Alaskan waters, we routinely anchor in ten to twenty fathoms with little room to swing towards shore. Anchor scope of 4:1 is a downright luxury, and we sometimes have to settle for 2:1. The safe solution is to use heavy gear and long chain. I went with a 35 pound Delta anchor, 150 feet of 5/16" proof chain, and 600 feet of 5/8 nylon braid. The weight of this tackle was too much for me, so I added a Lewmar V2 electric windlass. The windlass mounts on a new, 3-inch thick, laminated, white oak "apron" over the foredeck at the stem. A Garhauer anchor roller sits on this apron and extends beyond the stem about 6 inches. Due to the thick, tough oak, this was some of the most difficult carpentry I've done on Eagle Borne, but she looks salty and is very sturdy.

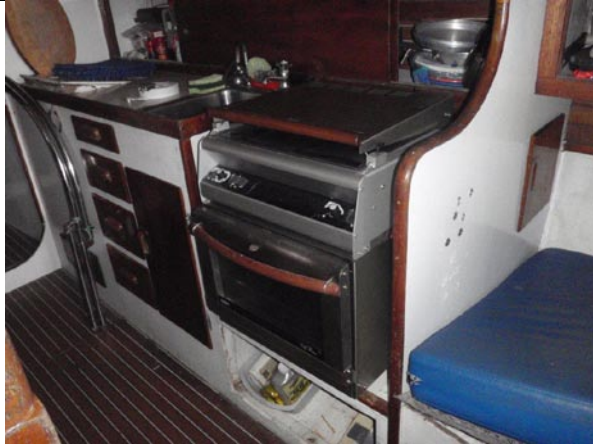
*Galley Range with stovetop cover "down" for cabin heating.*

**New Galley Stove and Oven.** The original Shipmate kerosene range with Primus burners was wonderful on a good day and horrible on a bad one. Unfortunately, I never got the knack of it so we had many smoky, polluted, bad days. I ditched the unit and its pressure fuel tank in favor of a Wallas *SafeFlame*<sup>™</sup> combination diesel oven and stove. This marine unit has sealed combustion, computerized ignition, and fan-powered exhaust. I mounted the stove on custom-made gimbals in the position of the original stove. There is no exposed flame anywhere, thus the name. The burner creates a hot plate on the top. Over the top is a stainless steel lid with a mercury-switched blower. Whenever the top is down, it blows air over the hot top and into the cabin. Did I say I was also able to remove a bulkhead-mounted Primus cabin heater? The Wallas unit could not heat the cabin one winter day (10 degrees F) in the harbor but it is fine in 40 degree weather.

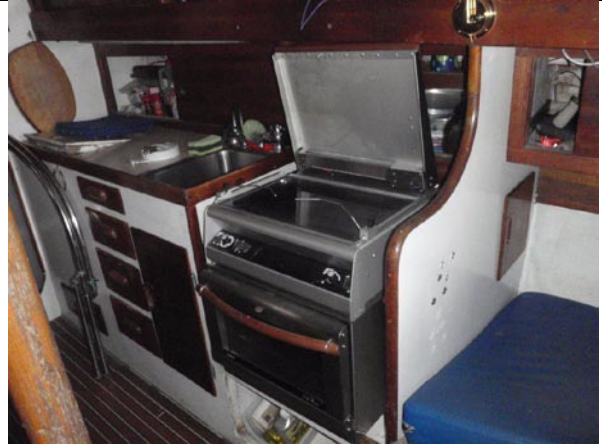
*Galley Range with stovetop cover "up" for cooking*

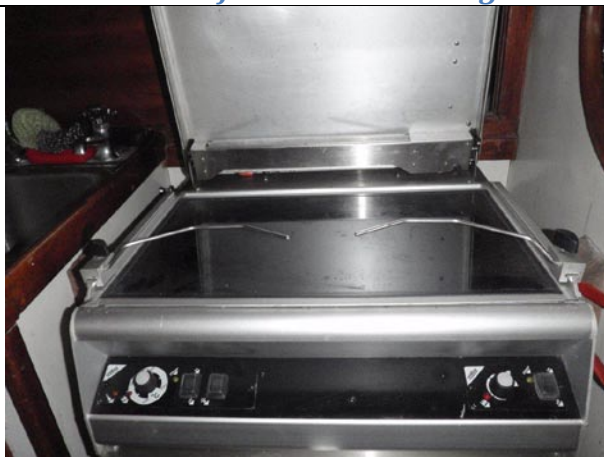
*Galley Range with burner controls.*

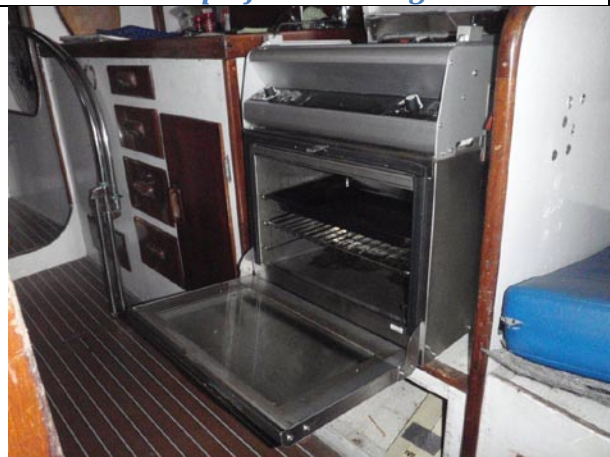
*Galley Range with oven door open.*

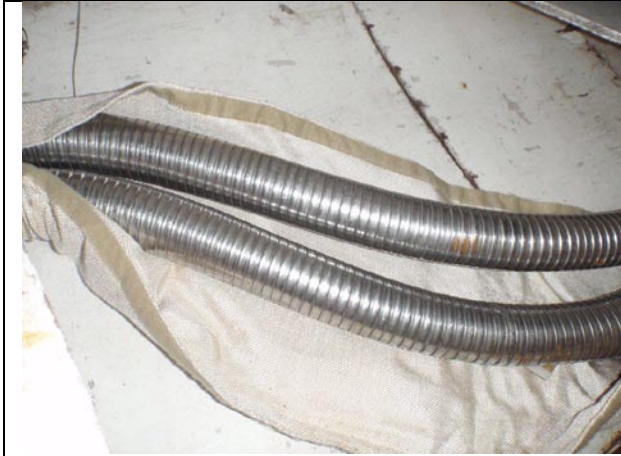
*Galley range exhaust pipes led aft under the starboard quarterberth.*

The exhaust is plumbed through 2" diameter, flexible, stainless steel exhaust piping that I got from an auto supply store. The exhaust terminates at a specially made tailpipe in the transom. This is about 15 feet of pipe for each exhaust (stove and oven), but by using the 2" size there is no restriction to exhaust flow and the unit runs perfectly. I have insulated the exhaust pipe with a removable blanket, and I drain the low points.

I had a little trouble with condensation in the exhaust pipes which initially blocked the exhaust and extinguished the burner. I found that a tiny drain hose with a p-trap fitted to a low point in the exhaust pipe would allow the condensation to drip into the bilge where it is pumped out with other water. The condensation rate is miniscule. It never accumulates now, and the burners can run smoothly for days on end.

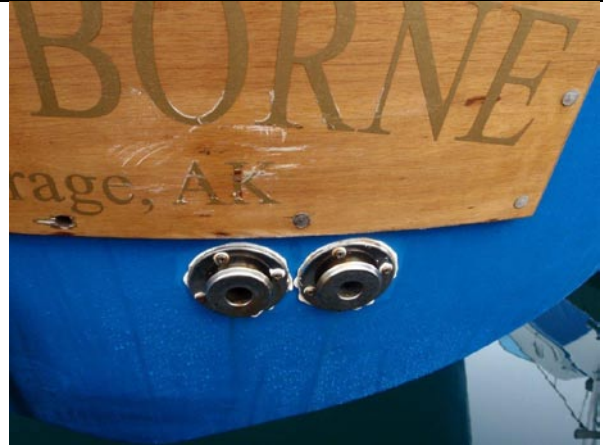
*Galley range exhaust pipes terminate on transom. Burner fumes are removed from the cabin.*

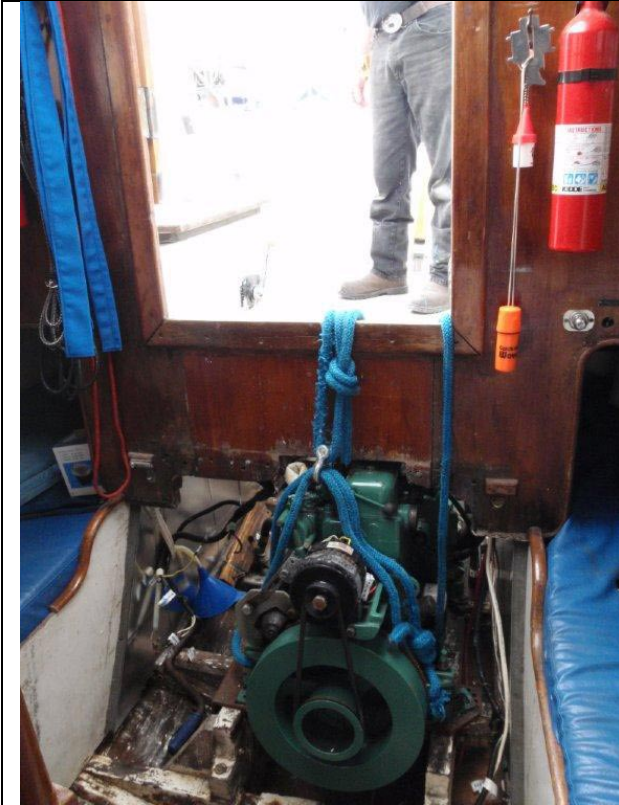
*Old engine rigged for lifting*

**Repower the Auxiliary.** Her old Volvo MD11C was smoking and coughing when I bought her, so I had it rebuilt for about \$5000 and put it back in myself. I lined the engine compartment with a Sailor Solutions Soundproofing tiles. The rebuilt engine ran well and served all purposes. She would cruise at 6 kts with a 15Lx11 prop while sipping .3/4 GPH of diesel.

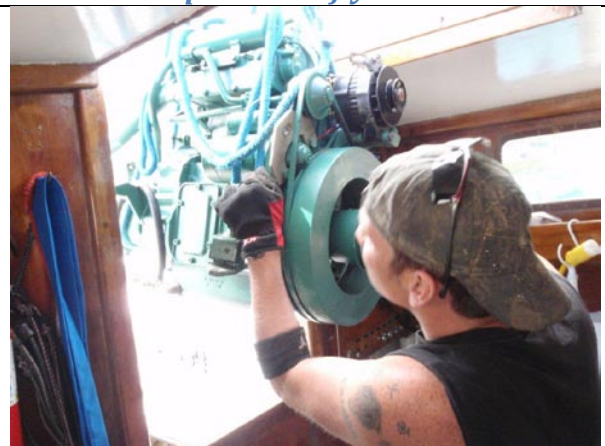
*Positioning the engine took delicate handling and some muscle.  
The route goes like this:  
1) forward into the companionway,  
2) down into the cabin, and  
3) back onto her motor mounts with only one inch to spare.*

However, the raw water cooled engine developed a cooling blockage which allowed one cylinder to overheat. The engine would slowly grind to a halt after running fine for a while. All suggestions pointed to fuel train and a clog or failed pump, so the correct diagnosis came slow. By then the second cylinder must have gotten scored and she ran rough. I'm a DIY boat owner, so I looked around for a simple option to repower once again. A brand new engine would have been the most reliable, and I found that a Beta would fit in nicely, but I did not want the additional work of reconfiguring the motor mounts, drive shaft, fuel, throttle, shifter, and electrical harnesses. I found a rebuilt Volvo MD11C for about \$5000 which had been upgraded to fresh water cooling with the Volvo heat exchanger kit, and I installed it in 2010. The only modification needed was some carpentry on the companionway stairs to make a little room for the heat exchanger and fresh water pump. We are optimistic that this will last us a whole generation.

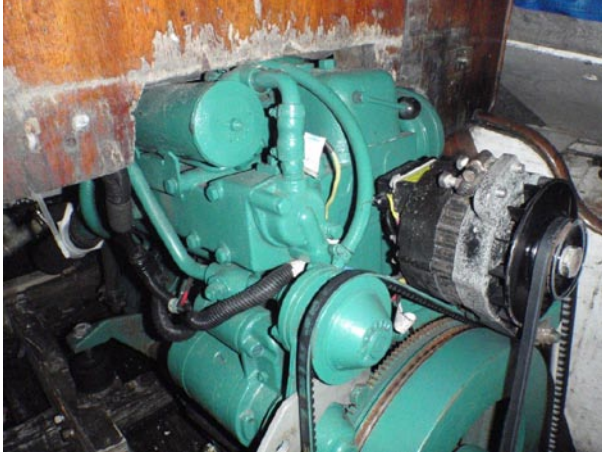
*Water pump belt runs under the alternator. A custom mounting bracket was required to tension the alternator belt.*

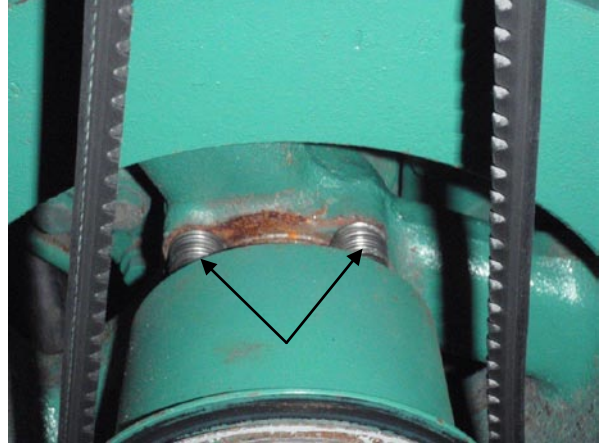
*Extended mounting bolts and spacers (washers) were needed to extend the alternator belt drive sheave out in alignment with the alternator.*
