I truly fell in love with my L-36 *Eagle Borne*. As a tinkerer and DIYer I found (or made up?) more new and exciting projects than a mad scientist in a chemistry store. In an effort to make her more seaworthy, safe, comfortable, and beautiful, I worked on her continuously. Projects sometimes overtook my coveted sailing time, as in the case of the engine failures and the hole in her bottom. Everything took twice as long as I initially figured, and many of the projects were twice as expensive. Nevertheless, I doggedly continued until I conquered them all. There are still some projects that I once had intended to do first that never were done at all. Priorities change. Still, I think she's undergone enough of an overhaul that the burden of continued maintenance will subside to an easier pace.

Here is a list of the upgrades and repairs I made on Eagle Borne since buying her in 2004. Not everything was done to master shipwright standards, but everything was done – and done with my own two hands. There are many smaller repairs and upgrades, like caulk and some minor rewiring, that did not make this list.

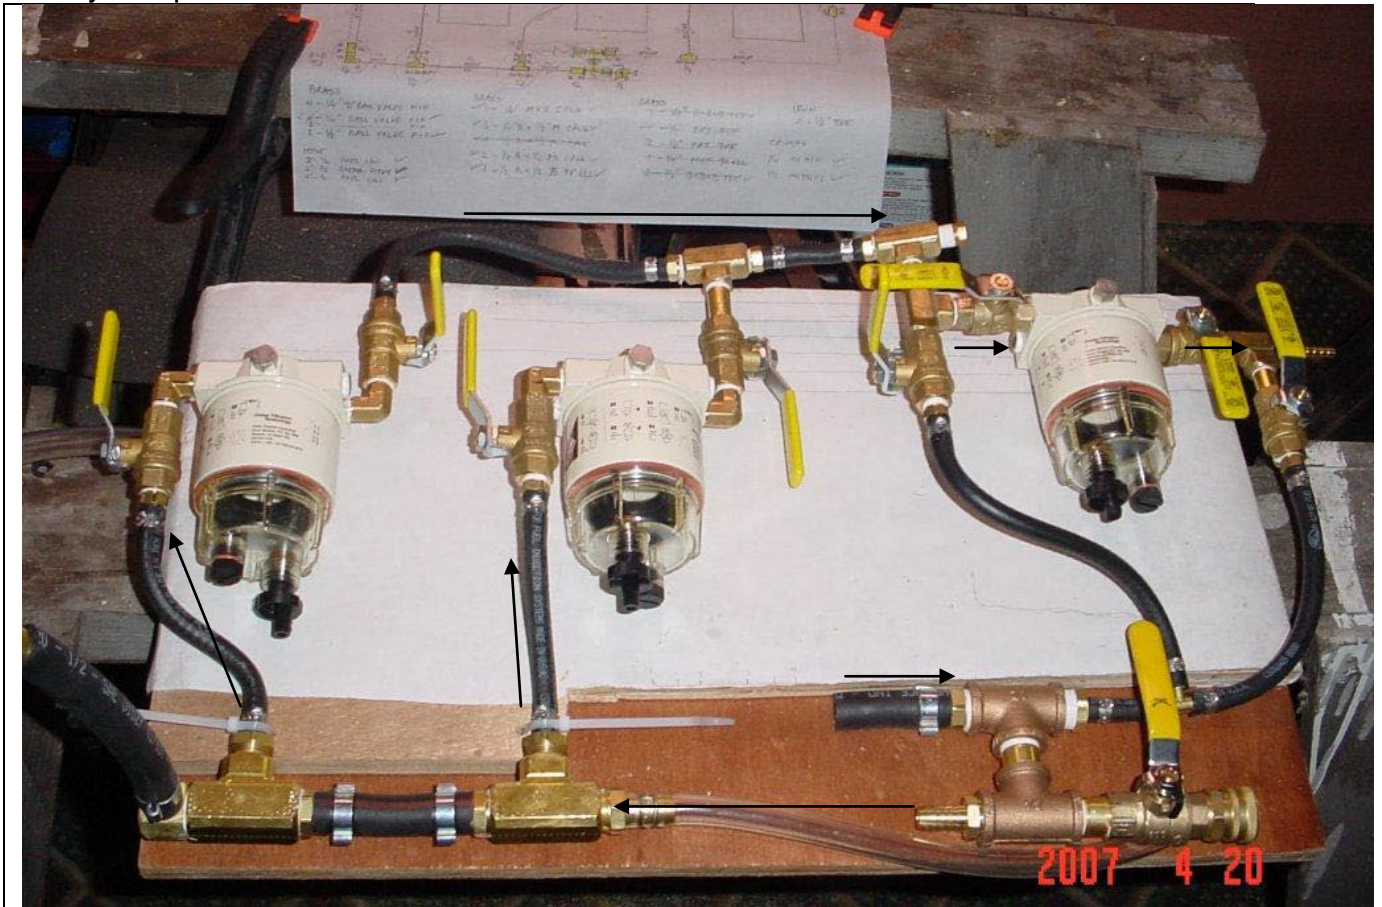
*Duplex two-stage filter bank with bypasses. Filters were assembled on a mounting board in the shop. Arrows show fuel flow direction.*

**New Fuel train and filters.** After repowering the first time, I added a two-stage parallel fuel filter bank. Fuel can now enter either of a pair of 10 micron, Racor filter/water separators. These are selectable in parallel and the elements can be changed with the engine running. Fuel then passes to a single 2 micron Racor filter/seperator before passing to the Volvo internal 2 micron filter. All of the new (Racor) filters have valved bypasses. The new Sailor's Solutions VGO1 vacuum gauge with drag pointer on the fuel bank indicates only about two inches Hg. restriction on the 10 micron bank, while Eagle Borne's original fuel vacuum gauge still registers less than three in. Hg restriction for the entire bank. The engine runs fine with these restrictions.

The filter bank was shop-mounted on a sheet of plywood. I then mounted the panel on the aft bulkhead of the engine compartment. On the fuel line there is a tee before any of the filters. This connects to a graduated sight glass which indicates the main fuel tank level. There is also a low-point drain. We have a 24 gallon galvanized iron tank.

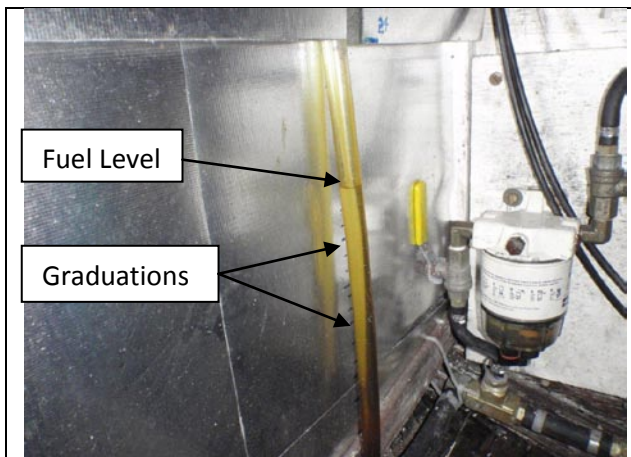
*Dip tube showing fuel level.  
Graduations are barely visible in  
this view.*

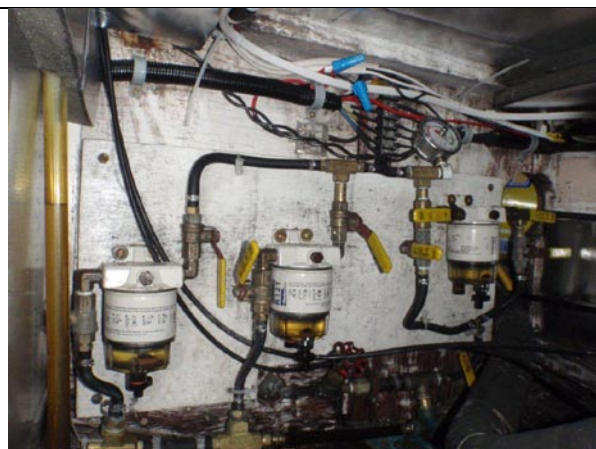
*Filter bank mounted on the engine  
compartment aft bulkhead.*
